REPUBLIC OF KENYA
COUNTY GOVERNMENT OF NAKURU
DEPARTMENT OF WATER, ENVIRONMENT,
ENERGY AND NATURAL RESOURCES

Report on Rising Lake Levels and Beaconing of the Highest Water Mark in Lake Nakuru, Kenya

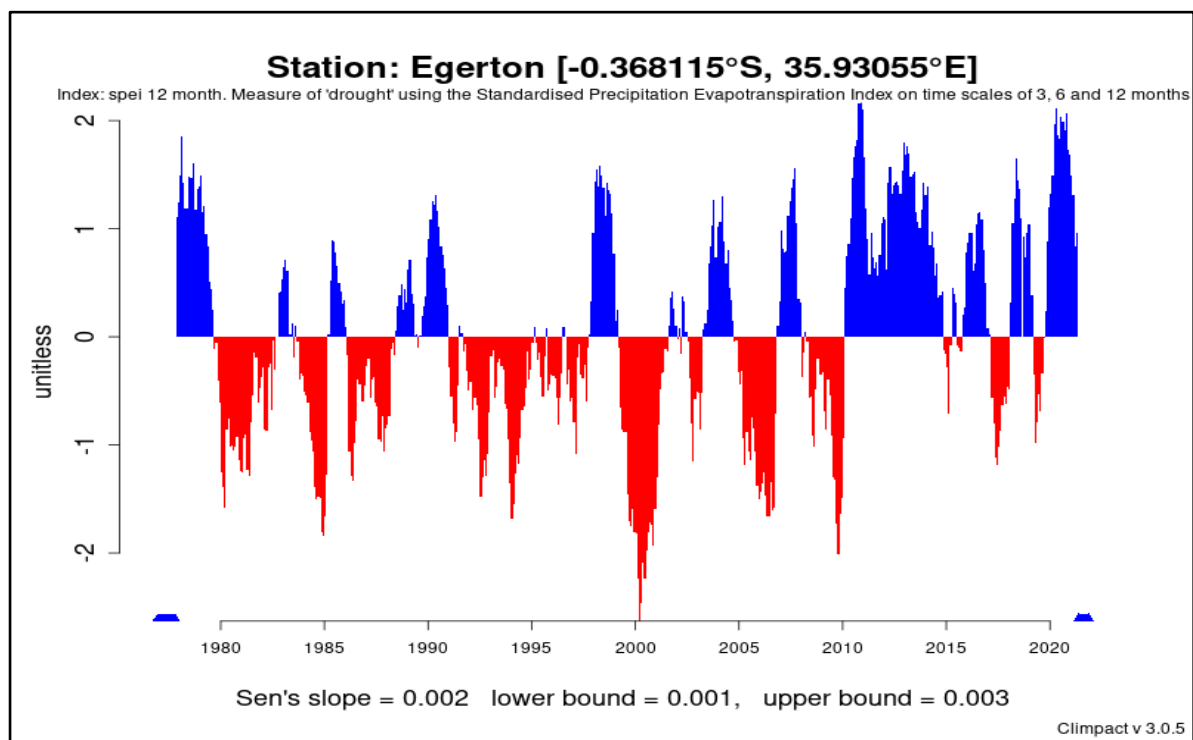
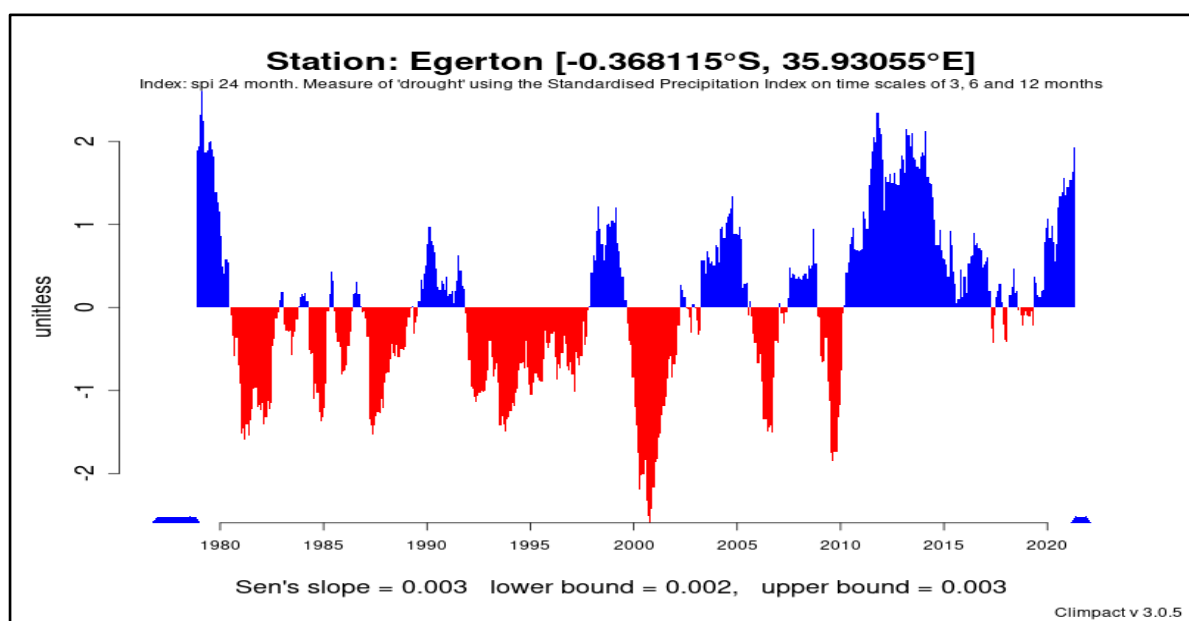
Fig. 3 & 4. 12- and 24-Month Standardised Precipitation Index at Egerton University Met Station

The results of 12-month and 24-month analysis are shown in Figure x. From these graphs, the indices indicate successive moderately wet to severely wet 12- and 24-month periods from 2010 onwards.

Category	SPI	Probability (%)
Extremely wet	2.00 and above	2.3
Severely wet	1.50–1.99	4.4
Moderately wet	1.00–1.49	9.2
Near normal	–0.99–0.99	68.2
Moderate drought	–1.00 to –1.49	9.2
Severe drought	–1.50 to –1.99	4.4
Extreme drought	–2.00 and less	2.3

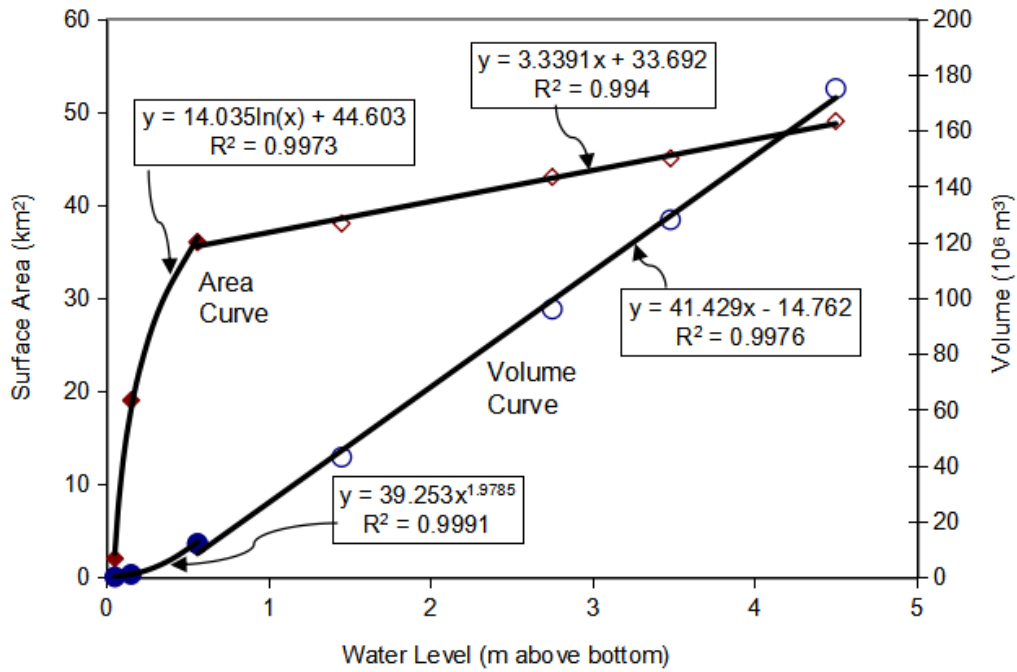
Figure: 24: Height Volume Area (HVA) curves of Lake Nakuru

Of these terms, the GW remains the most challenging component to estimate. Earlier studies by Becht *et al* (2006) and McAnn (1972) pointed out that Lake Nakuru has a net annual groundwater inflow of 24 and 23 million cubic meters. In this study, all the runoff from the sub-basins in Figure 18 was allowed to flow into the lake and the lake level and water surface area varied in accordance with the HVA-curves of the lake (Figure 23). The GW outflow from the lake was set as a fraction of the surface water inflows. It was found that a value of 0.835 produced the best fit as shown in Figure 24.

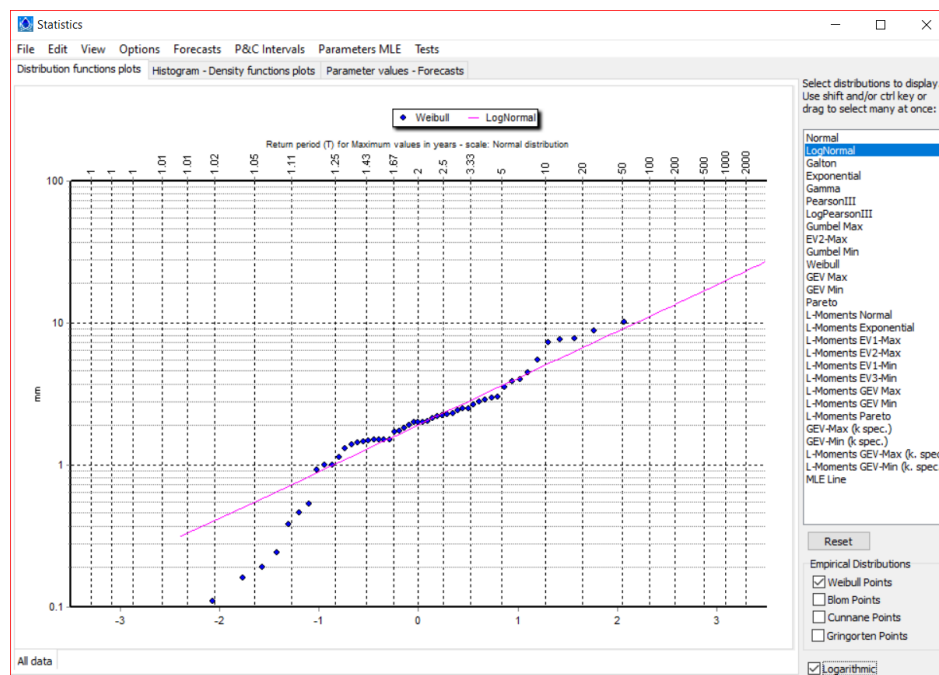
Figure 27: The frequency distribution of mean annual lake levels

The mean annual lake water levels (Figure 25) fitted a log-normal distribution as shown in Figure 26. Based on this graph, the extrapolated lake levels at return periods of 50 to 500 years are shown in Table 5.

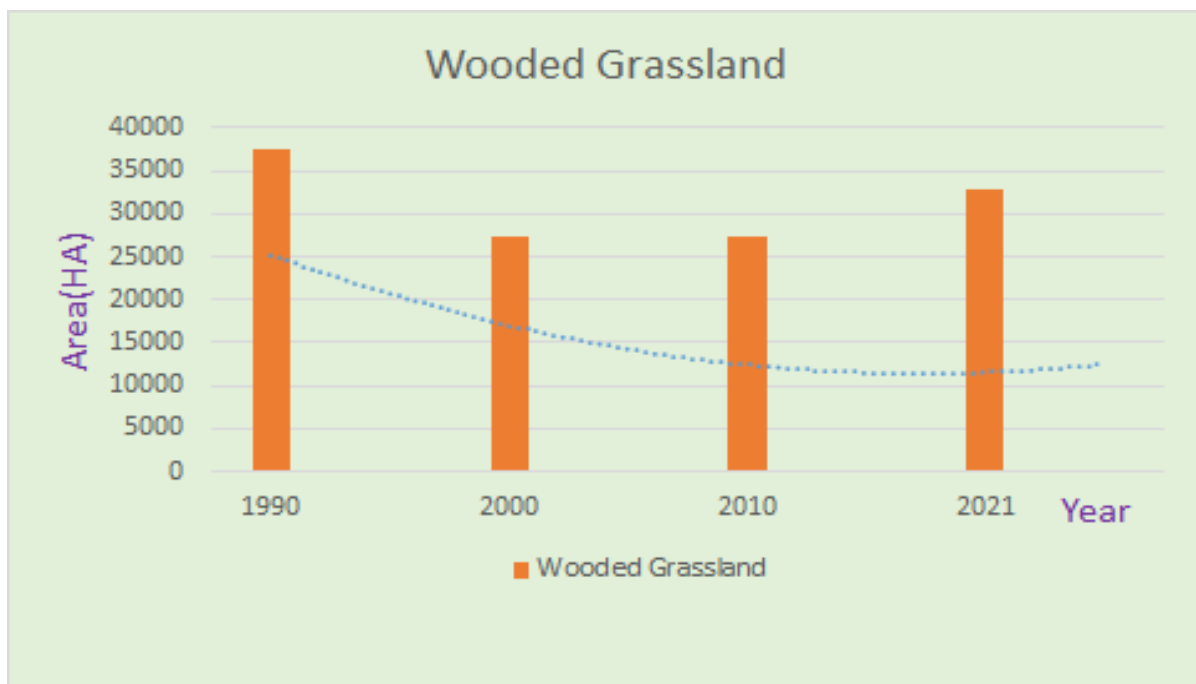
Fig.32: Graph showing trend in area under Wooded Grassland between 1990 and 2021

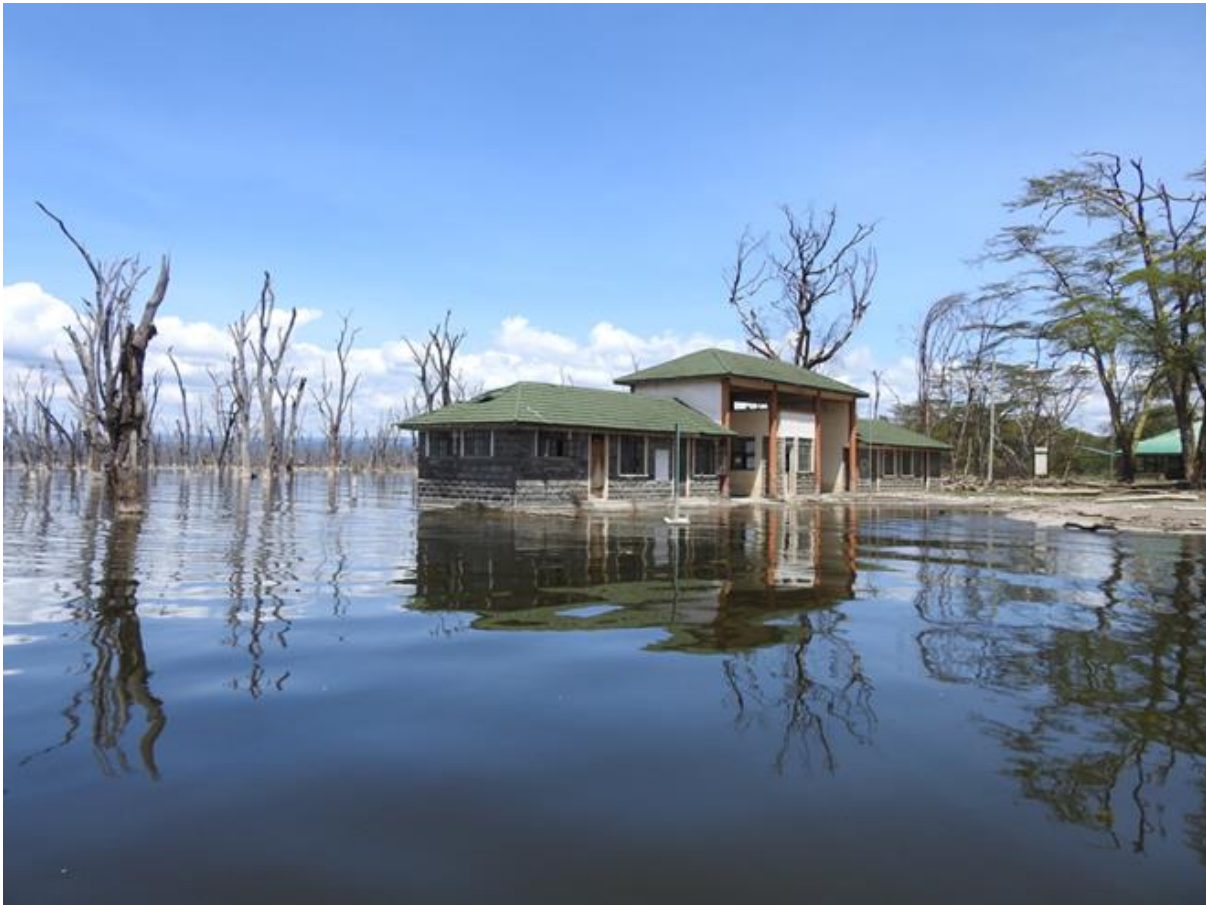
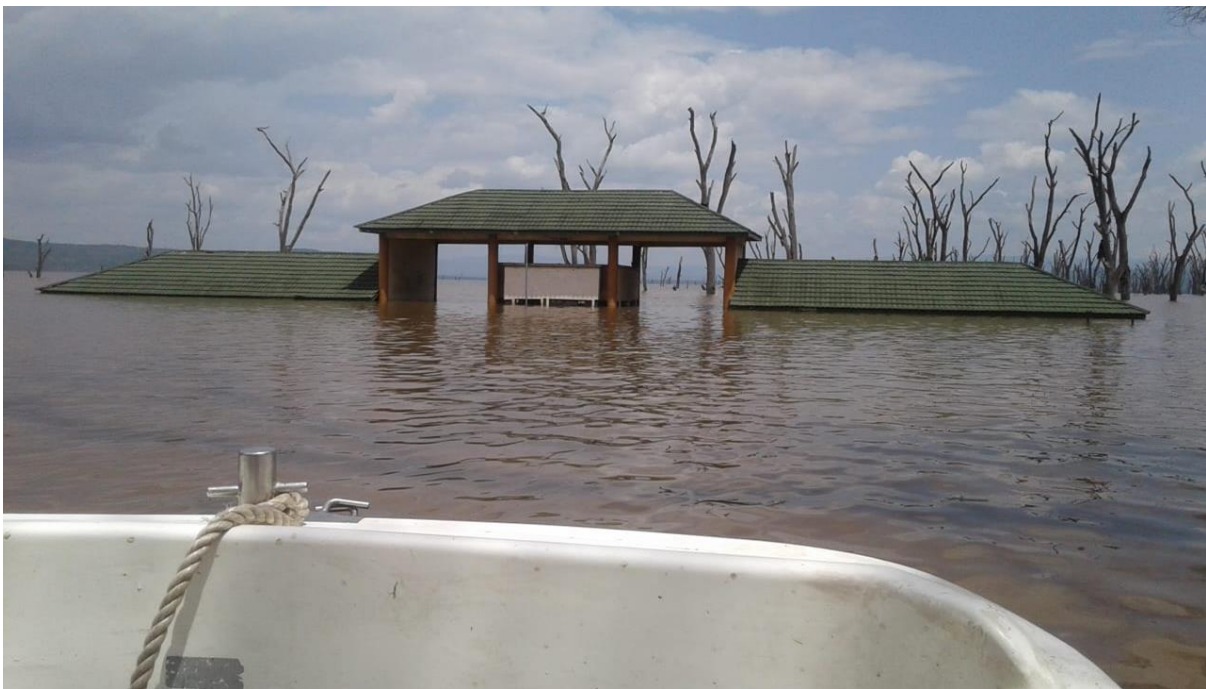
Photo. Lake Nakuru Maingate May 2019

Photo. Lake Nakuru Maingate September 2020

The pictures above show the submerged main gate.

It is estimated that KWS will require KES 25 million to replace the submerged gate, KES 4 million per kilometre to rehabilitate the 3 kilometres electric fence submerged (Ksh 12M in total).

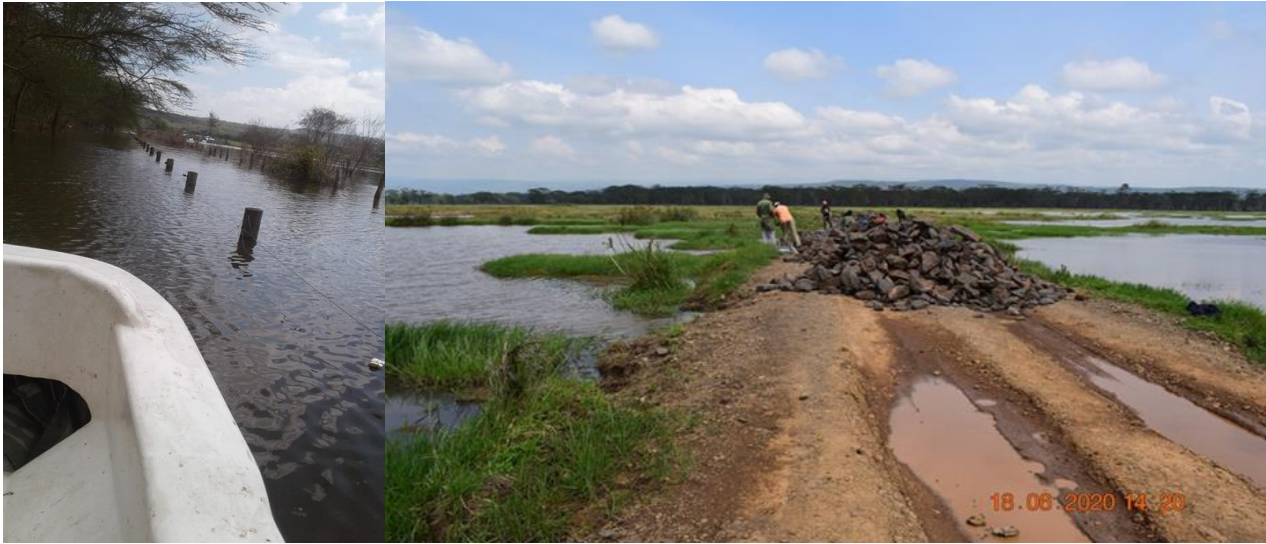
The photos above show the submerged fence along the park boundary

The pictures above show the submerged lake Nakuru National Park fence and the road repairs that were undertaken within the southern part of Lake Nakuru National Park at the mouth of Nderit river.
